**WATER TREATMENT**

**Maximize membrane life**

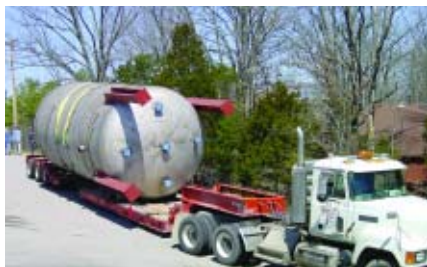
**4. Pay me now, or pay me later.**

Routine maintenance of rubber-lined demineralizer vessels extends their life and avoids the high cost of replacement. Proper inspections require specialized training and tools. *Courtesy: Corrosion Technologies Inc.*

The life of demineralizer vessel linings can be significantly extended with the proper combination of in-house examinations and regular inspections by a certified rubber lining technician. In an effort to save money, O&M crews are relying solely on visual inspection of their rubber-lined demineralizer vessels. Without the right tools and experience, you're probably not getting an accurate assessment of the long-term integrity of your linings (Figure 4).

To extend the life of a lining, the first step you should take is to open the manway during an outage and visu-

ally check the lining to confirm that rubber remains bonded to it, with no cracks or tears. Pay particular attention to 90-degree corners and high-stress areas. Always replace the gasket after each inspection and remember that the rubber lining is not a substitute for new gasket material.
